*Resource Conservation and Recovery Act (RCRA)  
Compliance Evaluation Inspection Report*

Cruzan Viril, LTD

Inspection Date: July 8, 2014

Project ID: CEPD-RCRA-14-0318

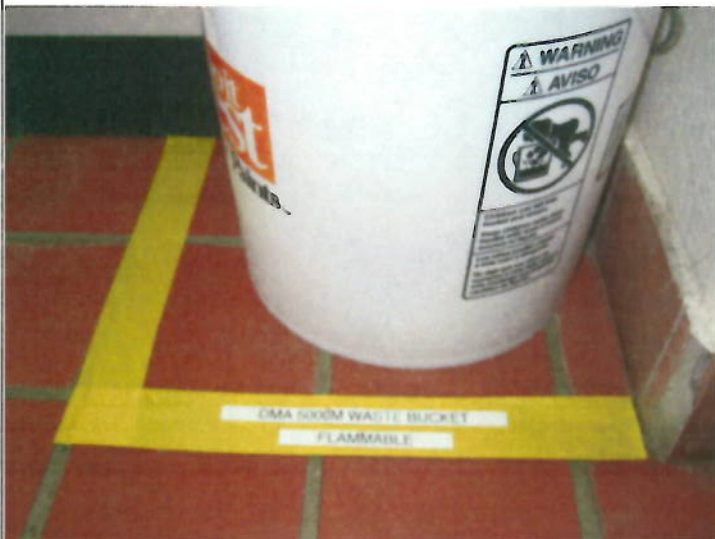
I proceeded to verify the SA's inside the laboratory and noticed two unidentified 5-gal containers. However, these were placed inside a (1ft by 1ft) area delimited with yellow tape, which identified the containers as follows: *DMA 5000M Waste Bucket-Flammable (Picture 1)*. According to Ms. Thelemaque, the Facility has in place an identification method, which requires personnel to identify the objects by placing tape in the area assigned to an object (i.e. tools, cabinets, instruments). Ms. Thelemaque emphasized that the laboratory personnel are the only one that implement this identification method. However, she indicated that as per the established procedure, the container should also be labeled.

Picture 1 — View of one of the two SA found at the Lab. The 5-ga container was not identified, but the accumulation area was identified as DMA 5000M WASTE BUCKET-FLAMMABLE.

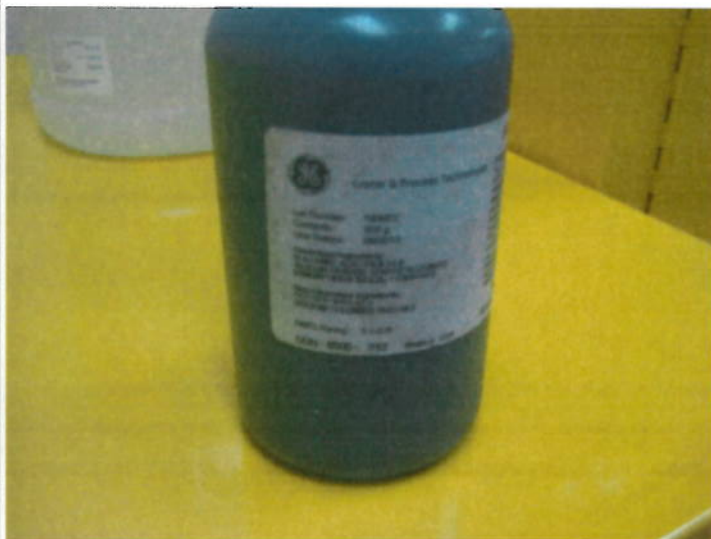
In our way to the HWAA, several bottles of lab chemicals were observed on top of a flammable cabinet. I inquired about these, and Ms. Thelemaque was unable to provide an explanation and decided to call a lab assistant who was working in the building's office. The lab assistant indicated that these were not in use and were placed there pending further instructions. I verified the labels on the bottles and found that at least five were expired. The following chemicals were found (**Pictures 2 to 6**):

Picture 2 — Expired Sulfite Indicator bottle found at the Lab.

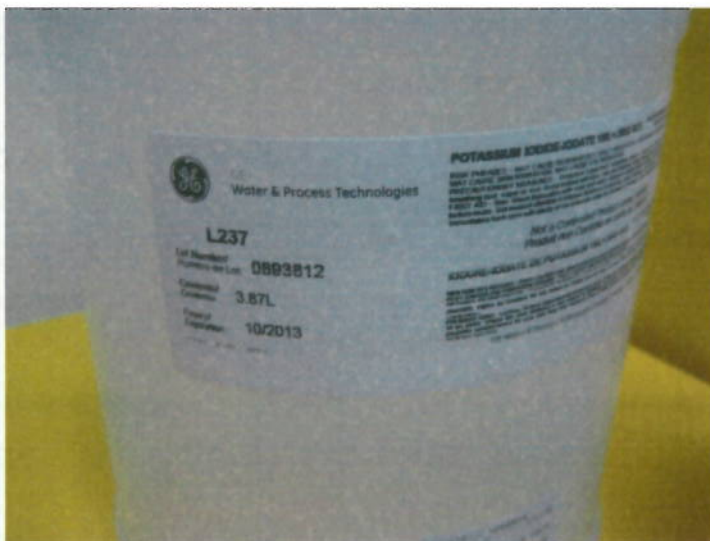
Picture 3 — One of the two expired Potassium Iodide/Iodate bottle found at the La

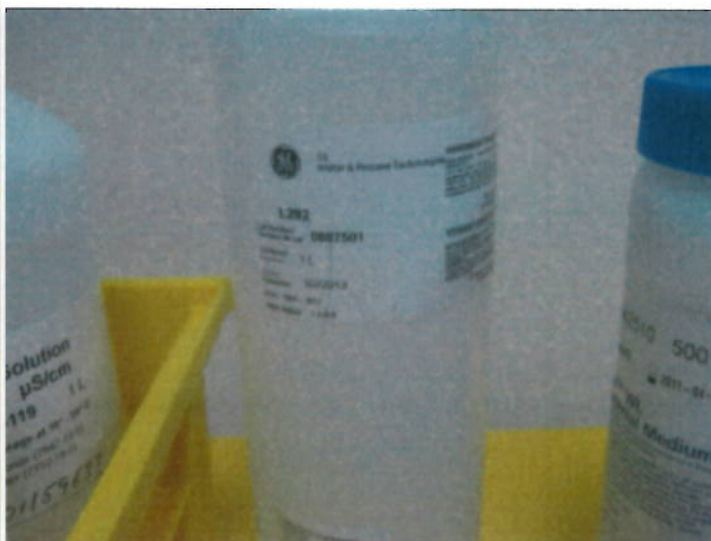
Picture 4 — Expired Hardness Tritant bottle found at the Lab.

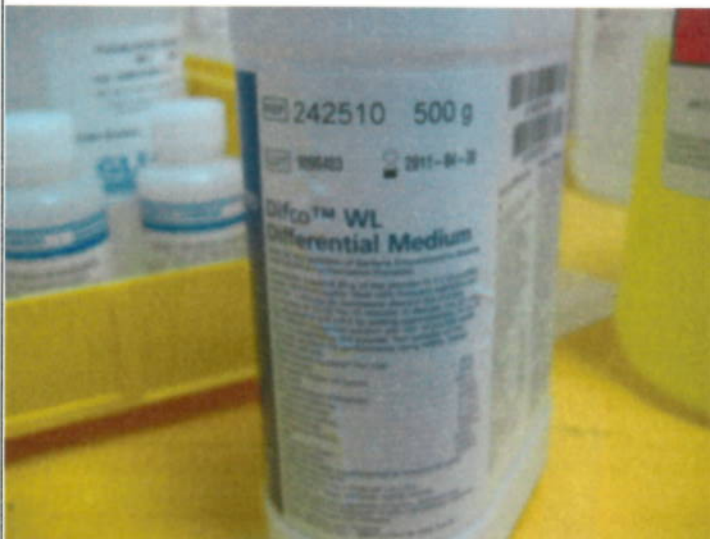
Picture 5 — Expired Differential Medium bottle found at the Lab.

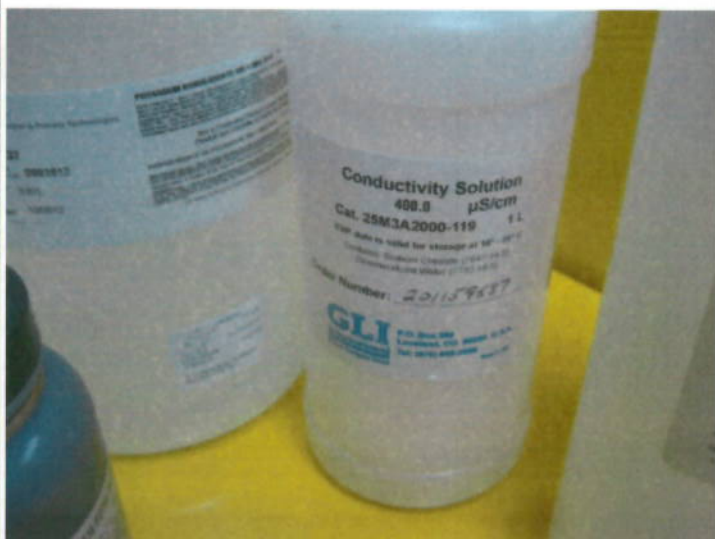
Picture 6 — Discarded Conductivity Solution bottle found at the Lab.

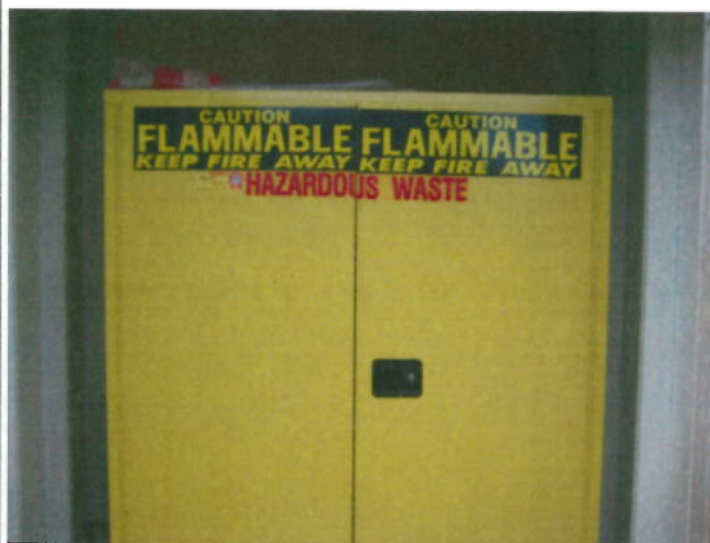
The HWAA is located outside the EHS/Engineering Building. It consists of a flammable resistant wall-locker identified with the words "Hazardous Waste" (**Picture 7**). According to Ms. Thelemaque, spent solutions derived from the lab analyses (i.e. DMA wastes) are poured inside a 55-gal container, once full it is disposed as hazardous waste through Virgin Islands Regulated waste.

Picture 7 — HWAA wall-locker found outside the EHS/ Engineering Building.

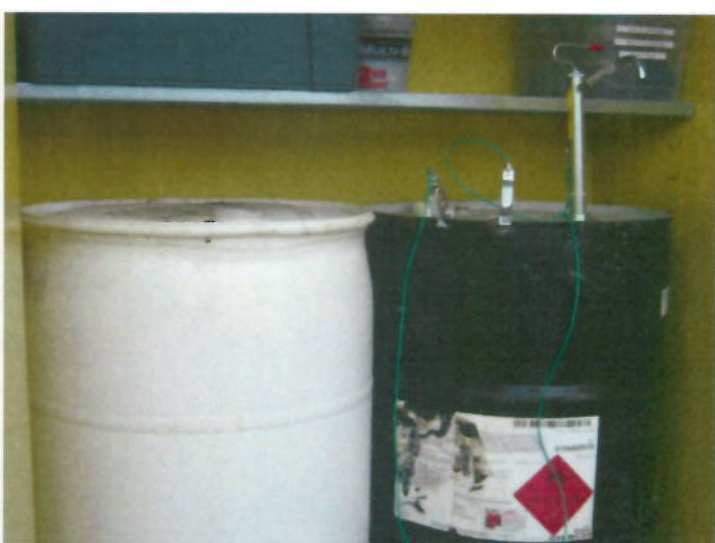
At the time of the CEI, one 55-gal container located at the HWAA did not have a label or mark with the words "HAZARDOUS WASTE"

At the time of the CEI, two 55-gal containers and a tray filled with glass bottles were observed inside the wall-locker (**Picture 8**). One of the containers (i.e. metal, black) had a *Flammable 3* label and had installed a dispenser system and grounding claps/wires. The other was an unidentified plastic and white container. According to Ms. Thelemaque, the black metal container was acetone, and the white plastic container was used to accumulate the hazardous waste derived from the lab activities. She was not sure about the contents of the glass bottles, which were placed inside the tray at the top-shelf of the wall-locker.

Picture 8 — Inside view of the HWAA, hazardous waste container was not identified or dated with the accumulation start date.

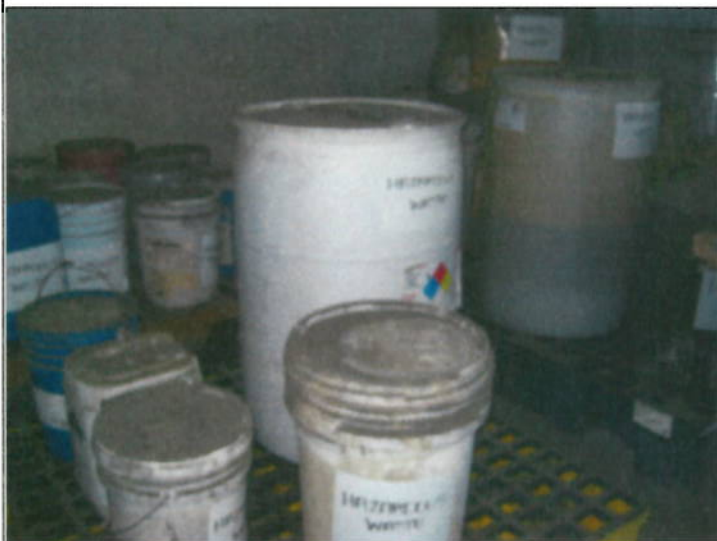
Several containers were deteriorated (i.e. broken seals, collapsed) and lids were covered with a thick layer of dust and dirt (**Pictures 9 and 10**). I requested information on the period of accumulation, but Ms. Thelemaque was unable to provide such information.

Picture 9— General view of hazardous waste containers found at the warehouse.

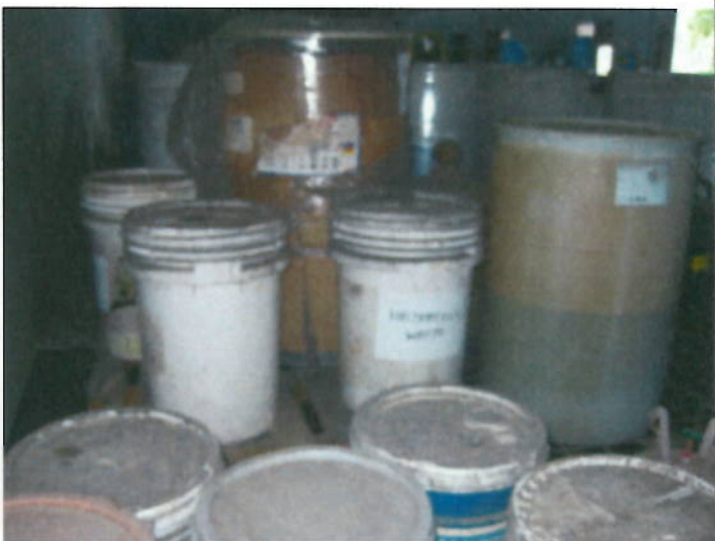
Picture 10 — Hazardous waste/discarded materials at warehouse.

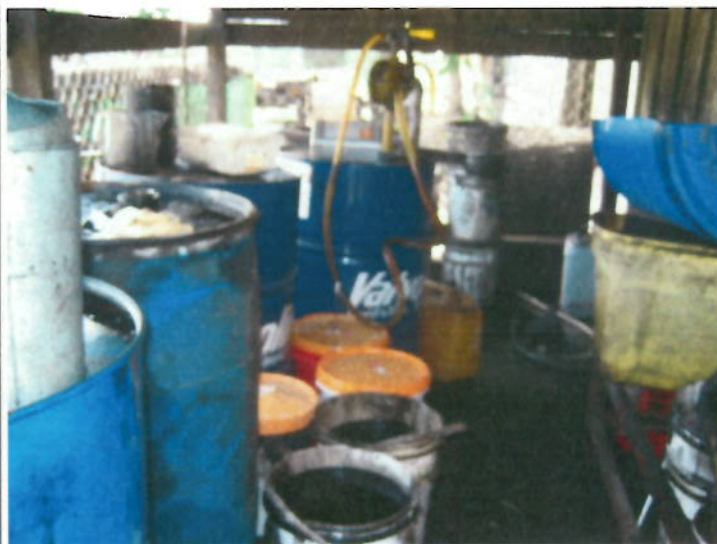
I proceeded to inspect the Used Oil Storage area and noticed several containers (i.e. 55-gal to 1-gal) with oil, lubricants and used oil (viscous and deep brown colored oil). At least two used oil containers were open and without the words "USED OIL" (**Picture 11**). In addition, several used oil spills and stains were observed inside the shed. Although, the shed is provided with containment, it is uncertain if it would be able to contain a release of oil/used oil<sup>2</sup>.

Picture 11— Inside view of Used Oil Storage Area-Shed.

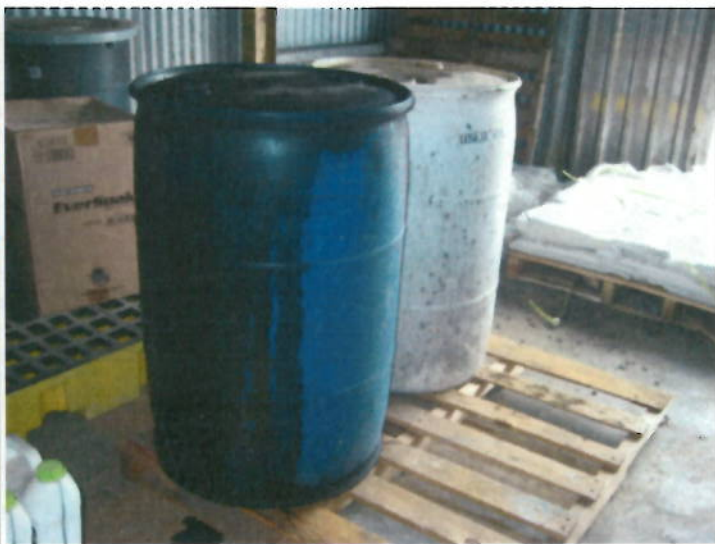
At the time of the CEI, the building was locked, but an employee who was working in the area unlocked the main doors for us. Inside, I found two 55-gal containers of used oil placed over a wood pallet. One of the containers was identified with the words USED OIL, the other was not identified and had evidence of spills and stains around it (i.e. dark stains). A used oil spill was observed near the before mentioned container (**Picture 12**). In addition, I observed two boxes of absorbent pads, paper bags/sacks of chemicals (i.e. polymer bags) and miscellaneous materials (**Picture 13**) placed over wood pallets.

Picture 12— Used oil containers found at the Chemical Storage Area.

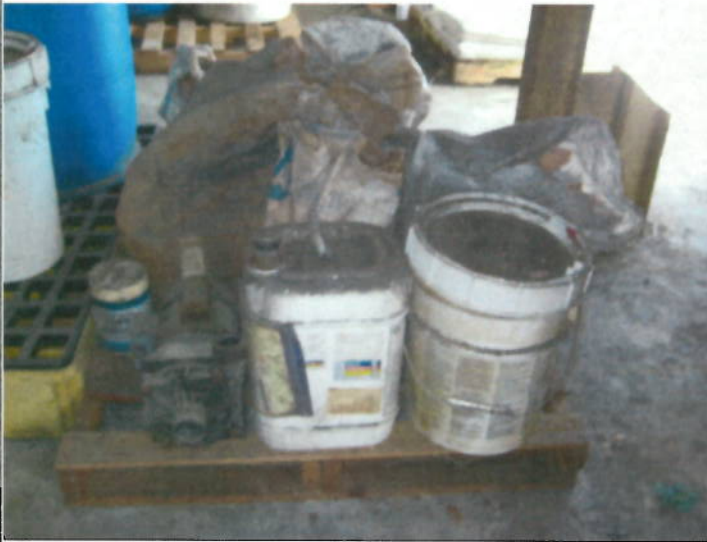
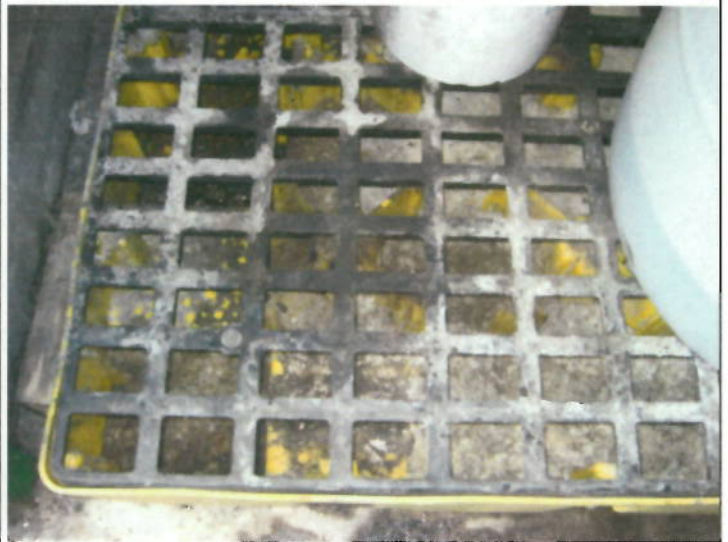
Picture 13— Abandoned-like materials found at the Chemical Storage Area.

Picture 14 — Top view of spill containment pallet. Evidence of spills/residues can be observed.

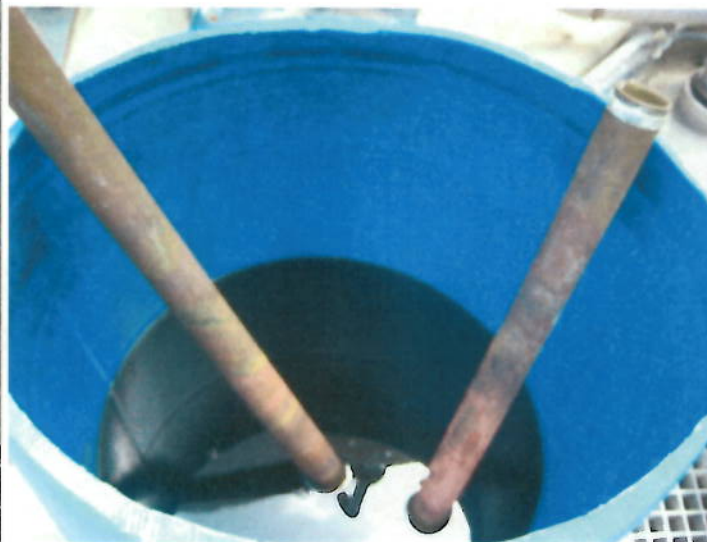
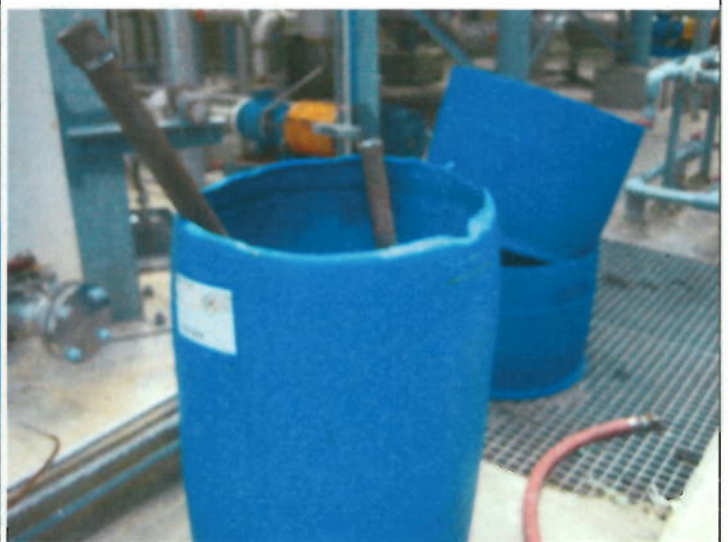
At the time of the CEI, a 55-gal container with oily substance and submerged pipe (**Picture 12**) was observed in the tank farm area of the plant. The container was open and exposed to the elements. I inquired Ms. Thelemaque about this finding, and she replied that she was not familiar with this practice. No additional concerns were noted in this area.

Picture 15 — Pipes submerged in oily substance. I was found at the CMS Plant.

Picture 4 — Container with pipes found at CMS Plant. The container was exposed to the elements.
